TRANSITION TEMPERATURES OF STRUCTURAL
STEEL BEAMS WITH BUTT WELDED SPLICES.

WILLIAM J. KREFFELD and GEORGE B. ANDERSON

Technical Report to Office of Naval Research and
Welding Research Council of the Engineering Foundation
Office of Naval Research Contract No-onr-271 - T.O. 7,
CU-1-53-ONR - 271-CE.

OCTOBER — 1955

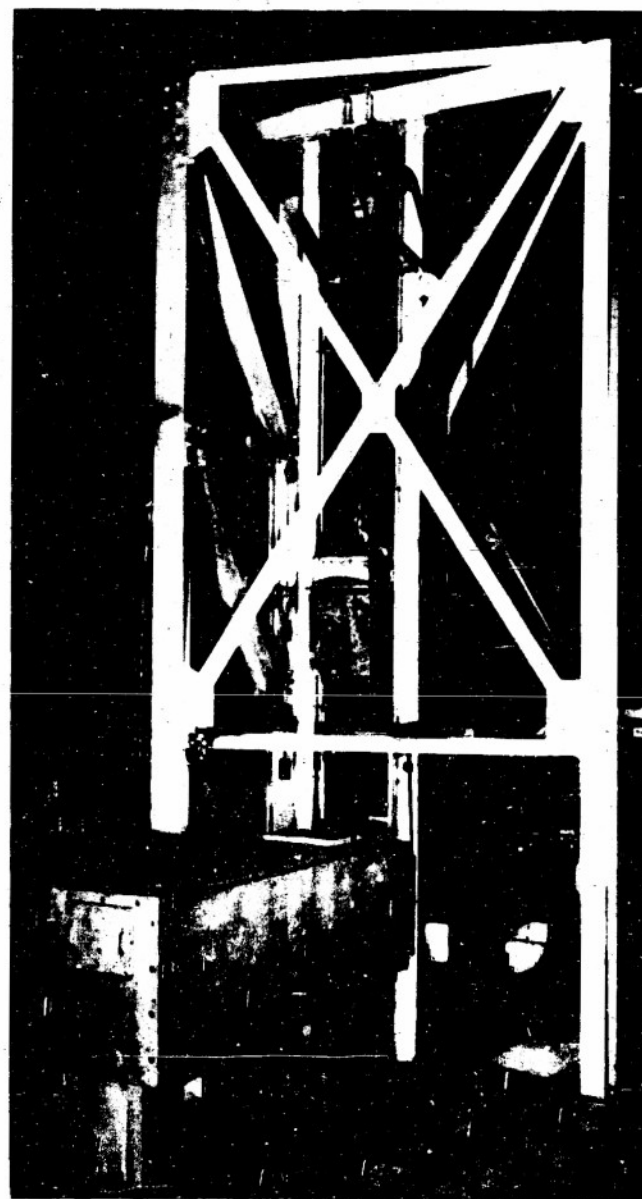
Plate 2 View of impact testing tower with beam specimen enclosed in cooling chamber

crement drop impact tests. The tower structure providing guides and lifting facilities for the tup was described in the report of previous impact tests. Some modifications were made in the beam supports and instrumentation, and the entire tower was re-erected on a more massive concrete foundation, bearing on rock.

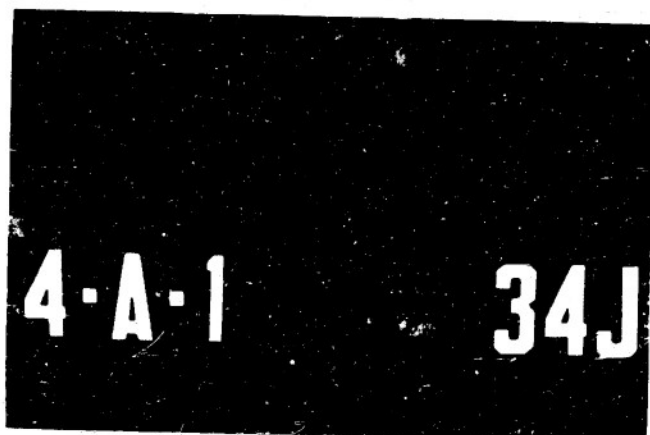
Plate 4 SK beam 4A tested as-welded at $+20^{\circ}\text{F}$. Tear in weld at top of hole. Beam buckled with deflection of 2.97 in. with no propagation of crack

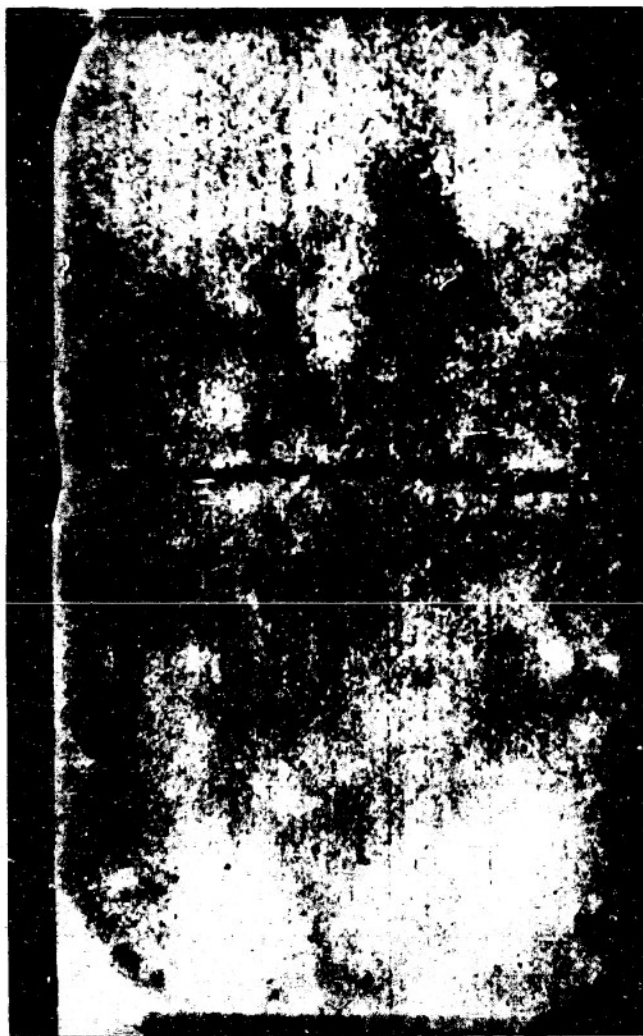
Plate 21A Internal fracture of web of Specimen 3B, SK $+30^{\circ}\text{F}$. Note necked-down and intact surface
